Installation Restoration Program

Final Report Phase II, Stage 1 - Problem Confirmation Study Norton Air Force Base San Bernardino, California

Volume I - Technical Report

July 1985

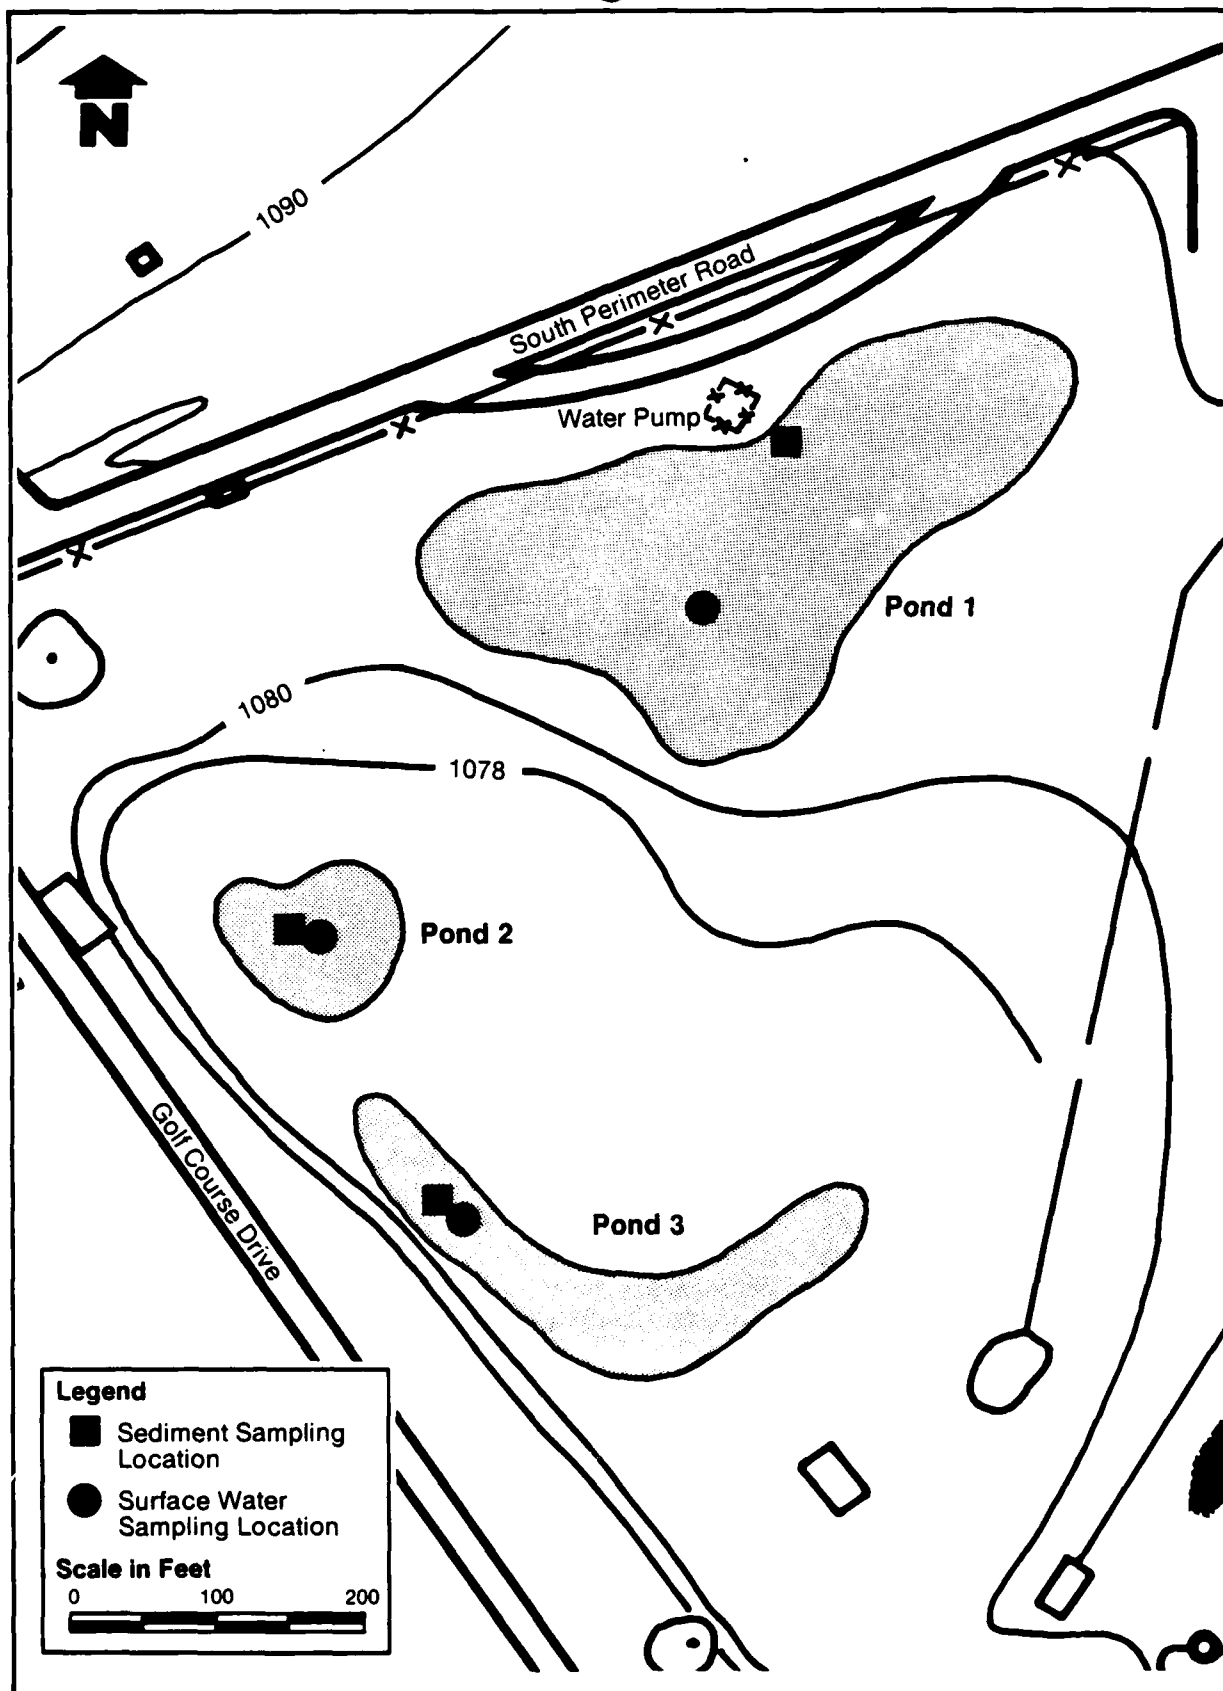
FIGURE 3-15 POND SAMPLING LOCATIONS

Bottom sediment samples were collected from Ponds 2 and 3 using a brass core sampler with a PVC-insert. Due to the presence of a cement liner, a sample of bottom sediment could not be obtained by this method in Pond 1. Therefore, a clean shovel and a stainless steel spatula were used to collect sediment from the shore of the pond immediately below the water level. Sediment samples were transferred to glass vials with Teflon septum caps, and amber glass bottles with Telfon-lined lids for the analysis of VOA (including MEK) and phenol, following requirements listed in Table 3-2.

In Pond 1, the seine net picked up only smaller fish from the shore area, and could not be used to gather a representative population. Neither electroshocking nor fishing with a line and hook were successful for collecting larger fish from the bottom.
